Re: Groundwater Monitoring Report - Fourth Quarter 2005

Seymour Residence 1111 Riverside Drive Rio Dell, CA LOP # 12032 Project # AE001H

On behalf of Jean and Everett Seymour, Clearwater Group (Clearwater) has prepared this *Fourth Quarter 2005 Groundwater Monitoring Report*. It presents background information, monitoring activities and monitoring results, conclusions, recommendations, and the planned activities for the referenced property (see **Figure 1** for a vicinity map).

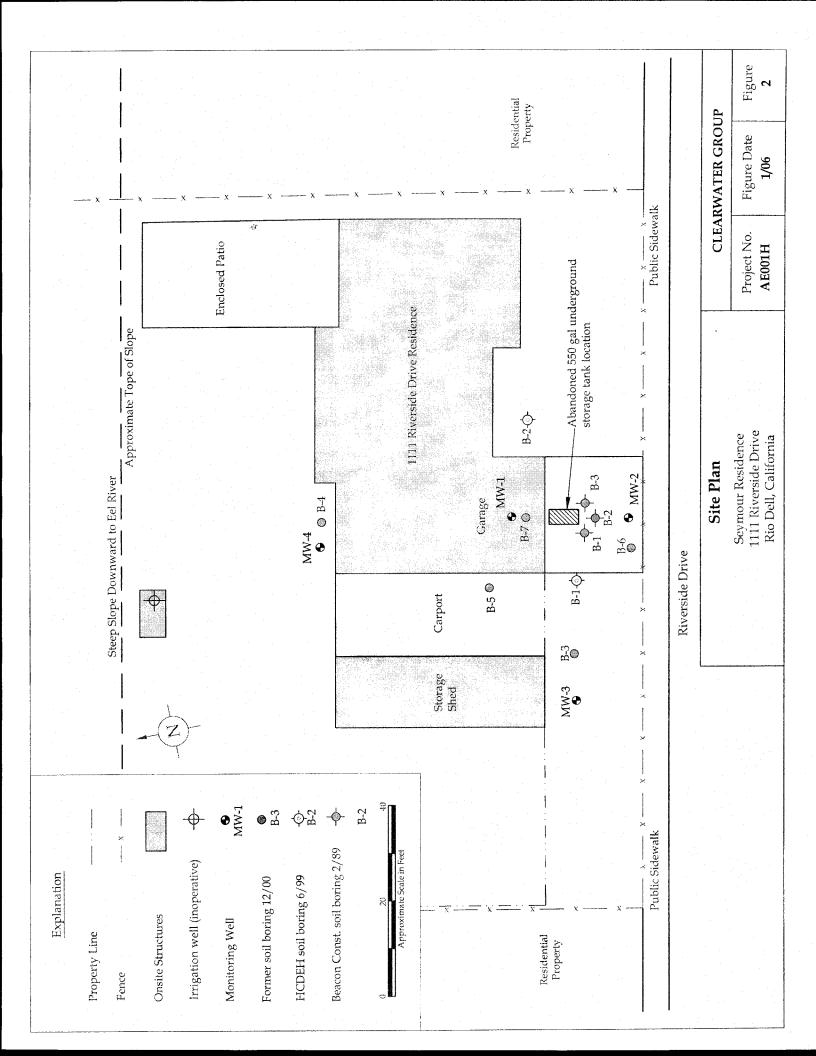
Figure 2: Site Plan

The subject site was improved with one 550-gallon capacity gasoline underground storage tank (UST). The tank location is shown in **Figure 2**. The tank was operated until 1987 when permitting began for in-place closure of the UST. In February 1988, the tank was abandoned in-place in accordance with the requirements of the Humboldt County Division of Environmental Health (HCDEH). According to HCDEH files, one soil sample was collected from an unspecified location by Beacom Construction of Fortuna, CA under HCDEH supervision in the vicinity of the UST at that time. Soil analytical results indicated that a release of petroleum hydrocarbons had occurred.

In February 1989, three additional soil samples (B-1, B-2, B-3, Figure 2) were collected by Beacom Construction from the south end of the (closed in place) tank. The depth and specific

In June 1999, the HCDEH collected groundwater samples from two borings (B-1 and B-2, **Figure 2**) from the vicinity of the closed UST. Each boring was advanced using a hand auger to a depth of approximately 7 to 8 feet below ground surface (bgs). The HCDEH also collected one groundwater sample from an on-site irrigation well (no longer used). Of the three samples collected by the HCDEH, only the groundwater sample collected from boring B-1 contained detectable concentrations of petroleum hydrocarbons. In a letter dated May 30, 2000, the HCDEH requested that a hydrogeologic investigation be performed. Clearwater subsequently prepared and submitted a *Workplan for Subsurface Investigation* dated July 19, 2000 to the HCDEH.

On March 7, 2002, Clearwater supervised the installation of four monitoring wells (MW-1, MW-2, MW-3 and MW-4, **Figure 2**) and initiated a quarterly groundwater-monitoring program. Results of monitoring well installation and the first quarterly groundwater monitoring were presented in Clearwater's *Monitoring Well Installation and First Quarter 2002 Groundwater*

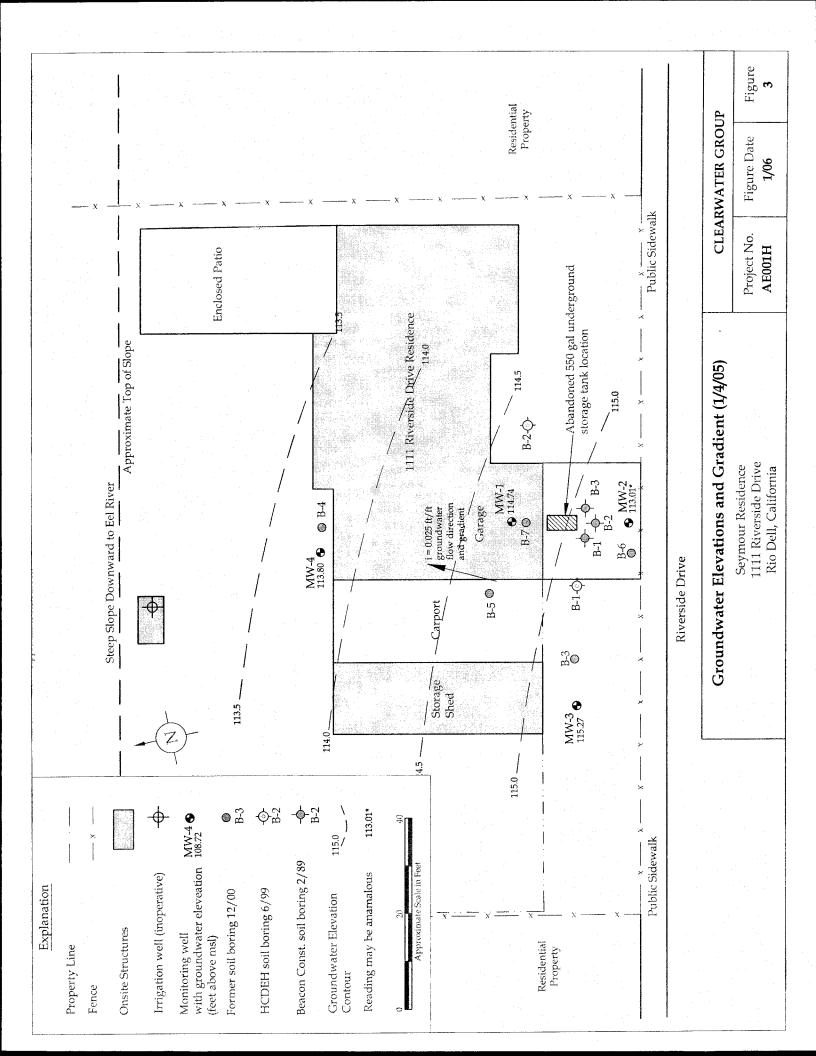
Figure 3: Groundwater Elevations and Gradient - 1/4/06

Flow direction/gradient: Northeasterly direction with a horizontal hydraulic gradient of

0.025 ft/ft (**Figure 3**)

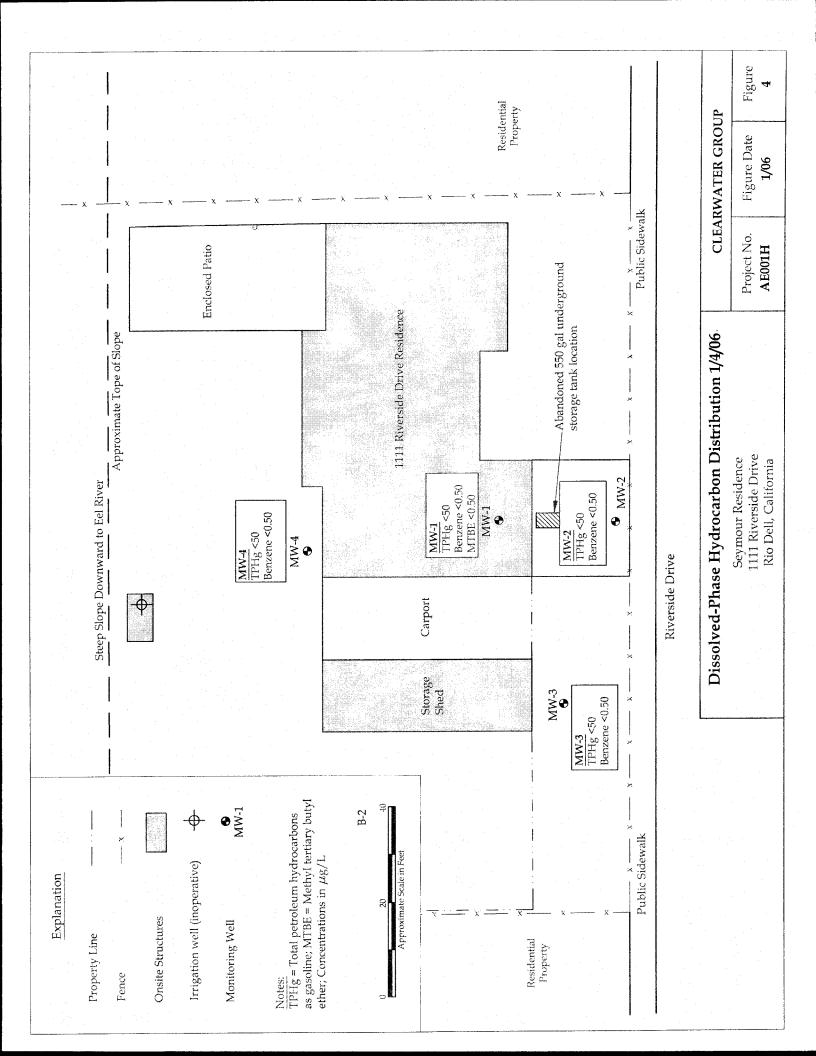
Figure 4: Dissolved-Phase Hydrocarbon Distribution - 1/4/06

TPH-g concentration: MW-1 through MW-4,  $<50 \mu g/L$

Benzene concentration: MW-1 through MW-4, <0.50 μg/L

MTBE Concentration: <0.50 μg/L (MW-1)

• Hydrocarbon concentrations were below detectable limits in groundwater samples obtained from all monitoring wells (MW-1 through MW-4)

- To confirm the expected groundwater remediation prior to site closure, quarterly monitoring should continue; the iSOC system should be maintained at its current operation until all wells report contaminant concentrations at non-detect levels for four consecutive quarters. Currently, there have been two quarters of non-detect levels in all monitoring wells.
- When four consecutive quarters of non-detect concentrations have been achieved with iSOC system in operation, at that point, Clearwater recommends that four quarters of post-iSOC treatment groundwater monitoring be performed to verify that no rebound occurs and the site is remediated.
